REPORTS ON PROPOSED QUARRY FOR THE  
PRODUCTION OF CURBING AND CRUSHED  
STONE AGGREGATE IN MEDINA SAND-  
STONE FORMATION AT HULBERTON,  
ORLEANS COUNTY, NEW YORK

MEDINA SANDSTONE QUARRY, INC.,  
OPERATOR

Paul H. Bird  
Associate Engineering Geologist

Albany, New York  
July 31, 1969

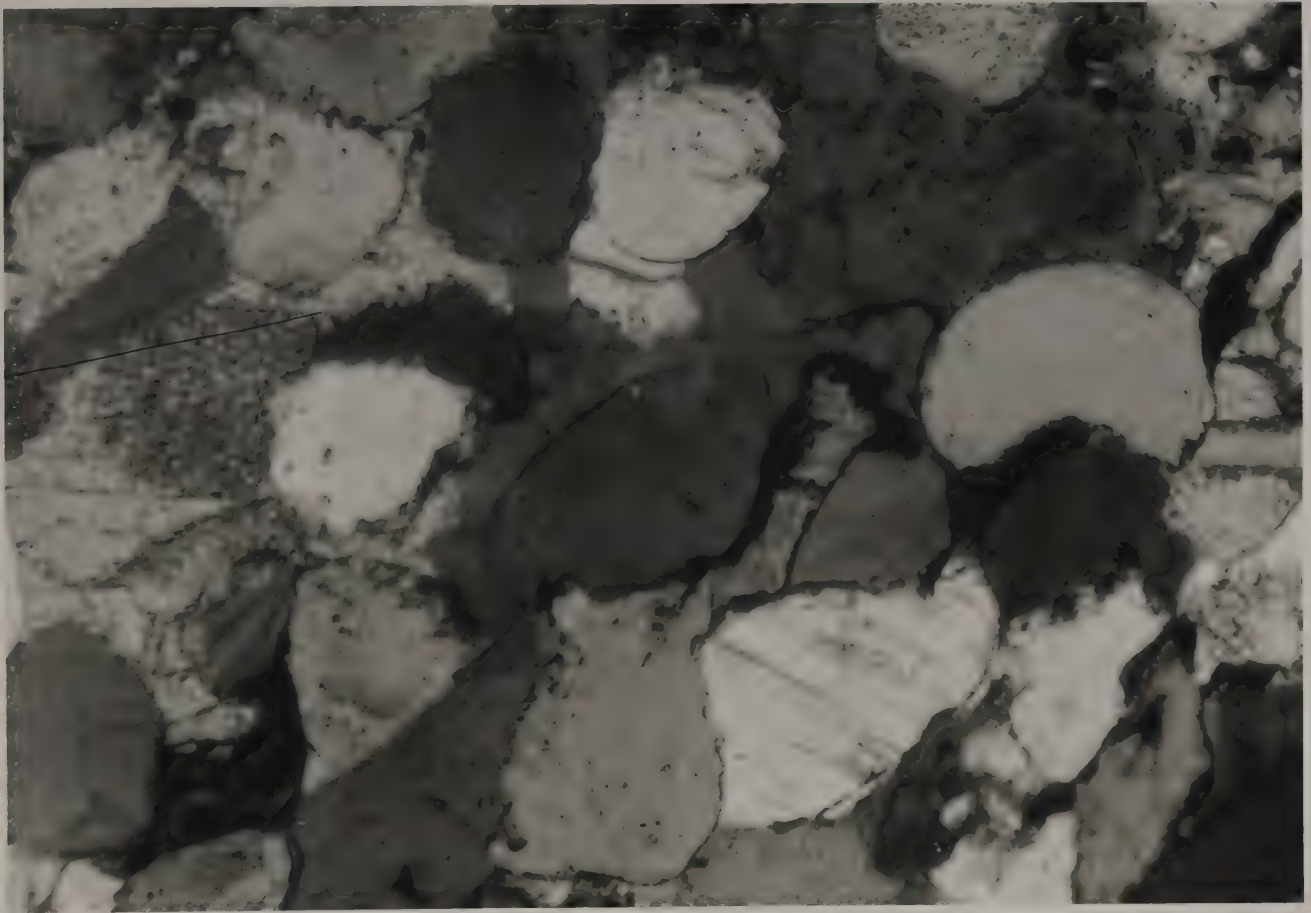
When these rounded sand grains were deposited they were coated with a thin film of red iron oxide, which imparts to the stone its characteristic reddish color. This film is undisturbed in many cases and serves as an outline of the original shape of the grains as shown in the accompanying photomicrograph. At the "welded" junctures it has been dislocated.

Photomicrograph at a magnification of about 150 times illustrating the features of stone from the Hulberton quarry. Taken with crossed polarized light to emphasize the internal structure. All the gray and white grains are quartz. The "pockmarked" grain, center left, is calcite. The real dark gray to black, irregular shaped masses and streaks are red iron oxide.

Note the gray grain of quartz in the center, the original rounded shape of which is shown by a hairline of iron oxide, except at the lower end where solution has destroyed the original shape and "welded" it to the adjacent grain below. The quartz on the outside of the hairline was deposited in an original pore space and is optically continuous with the quartz of the original grain.

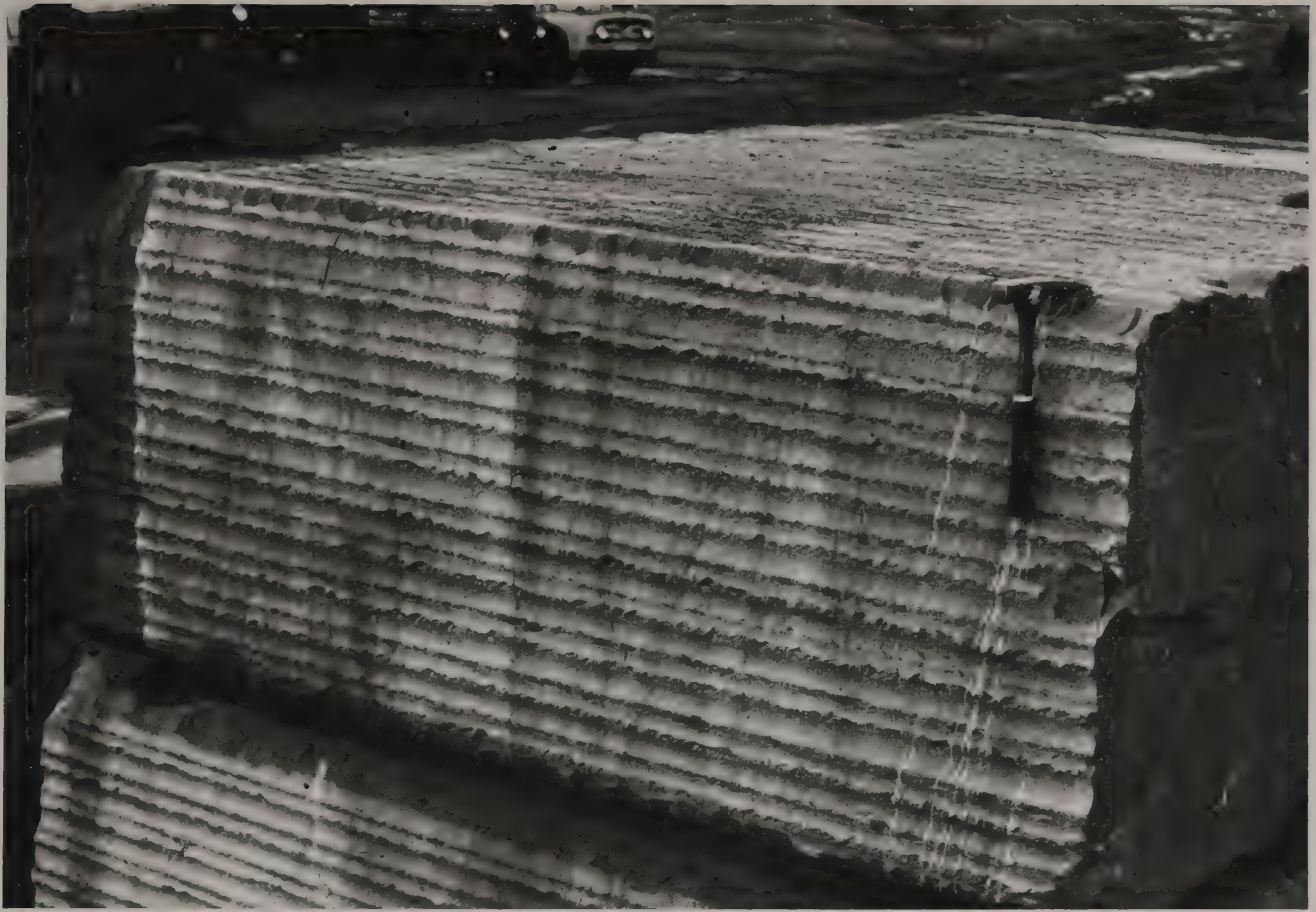
PHOTOGRAPH I

Taken in the yard at the Williams plant in Buffalo. The stone comes from the Hulberton quarry in the form of these large blocks.

Note: 1) The irregular bedding which appears vertical in the view; 2) The vertical, light toned streaks near the right hand end. They are parallel to the bedding and composed of a weak clay-like material that weathers rapidly.

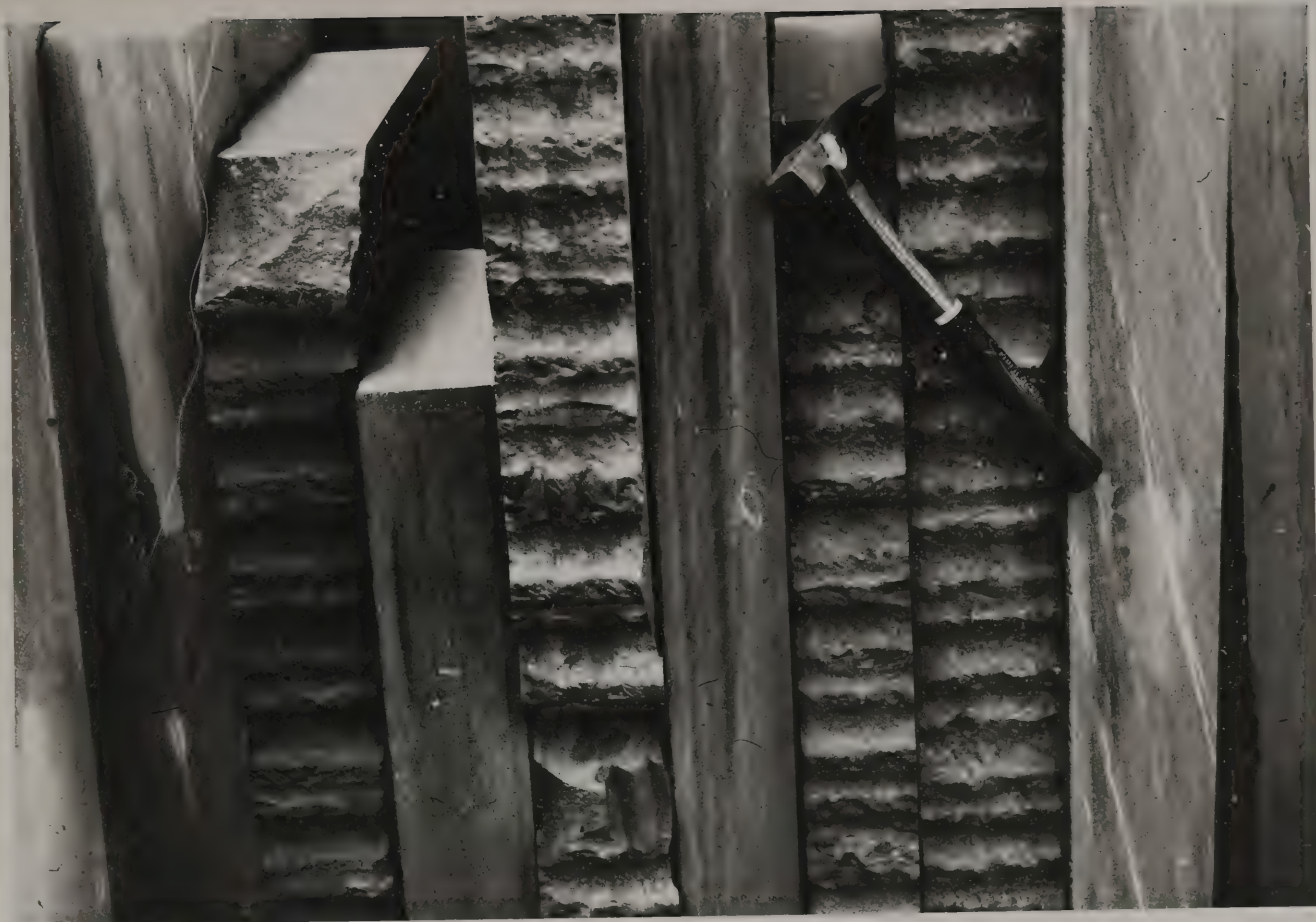
PHOTOGRAPH NO. 2

The only deleterious feature observed in the stockpiled curbing was a rare thin band of greenish to white, shale-like material as shown in Photographs No. 2 and 3, and this was seen only in curbing that was rejected by the producer. In fact there is curbing in place in Buffalo that is inferior to much of the rejected curbing in the Williams yard.

Taken in the Williams yard. The curbing shown here is of inferior quality and is not offered for sale. Taken to show the light colored material in the piece at the end of the hammer handle. This material is deleterious and curbing such as this should not be accepted. The same type of material is present as irregular shaped masses in the two pieces at the left hand side of the view. Note that the piece at the end of the hammer handle is split at an angle to the stratification.

This study has led to a confident recommendation that curbing from this producer is of acceptable quality so far as durability is concerned. The following restrictions, however, should be rigidly carried out: 1) stone only from the Hulberton quarry is acceptable; 2) curbing must be free of light colored, clay-like laminae as shown in photographs No. 2 and 3; and 3) only stone from the lift shown in photographs No. 4 and 5 shall be acceptable.

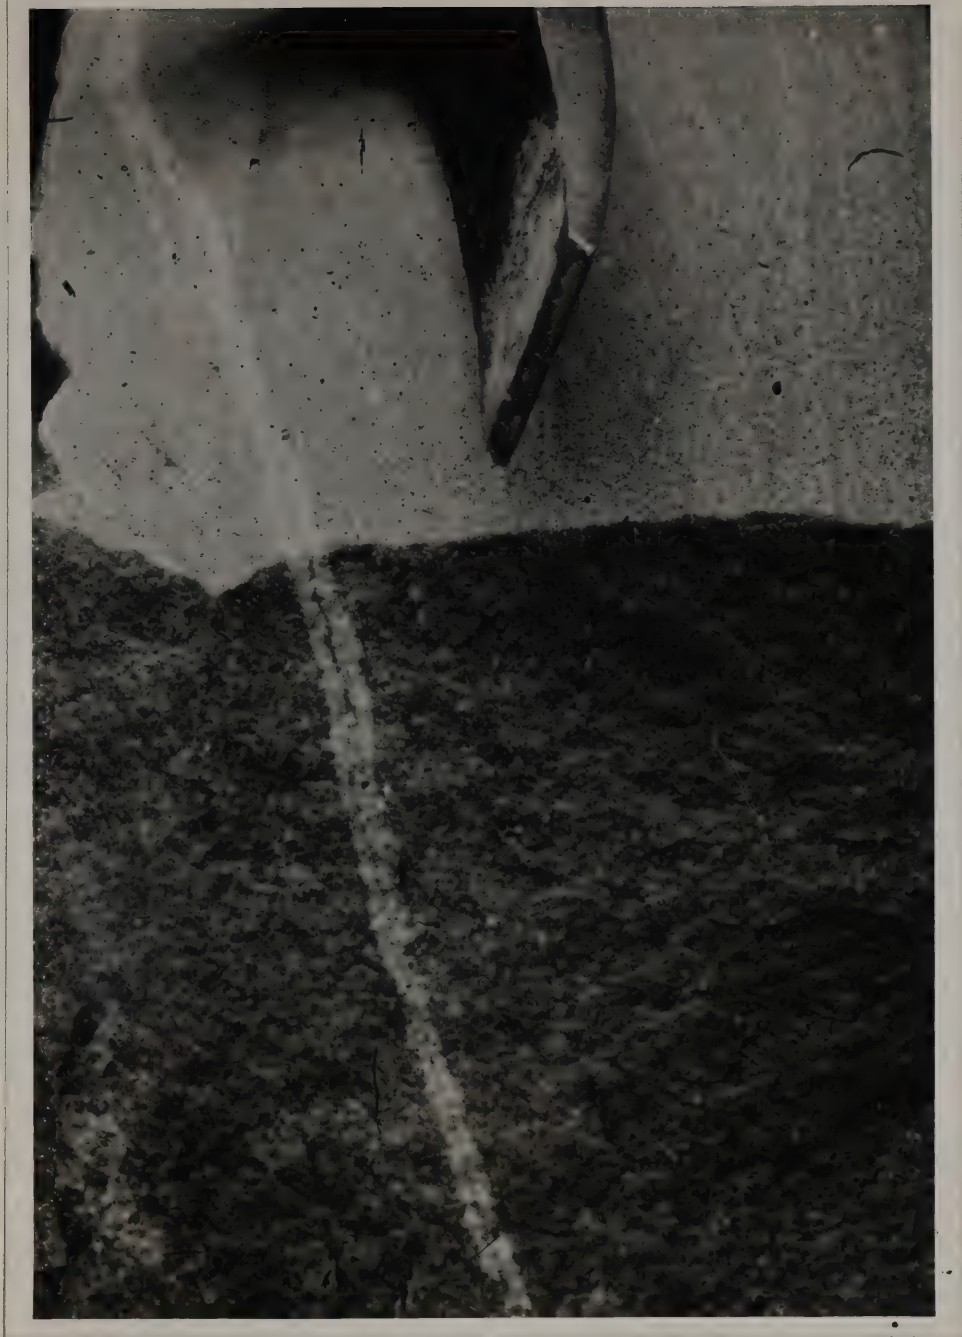
PHOTOGRAPH NO. 3

A view at about true size taken to show a close-up of one of the light colored, weak streaks. This piece also is split at an angle to the bedding.

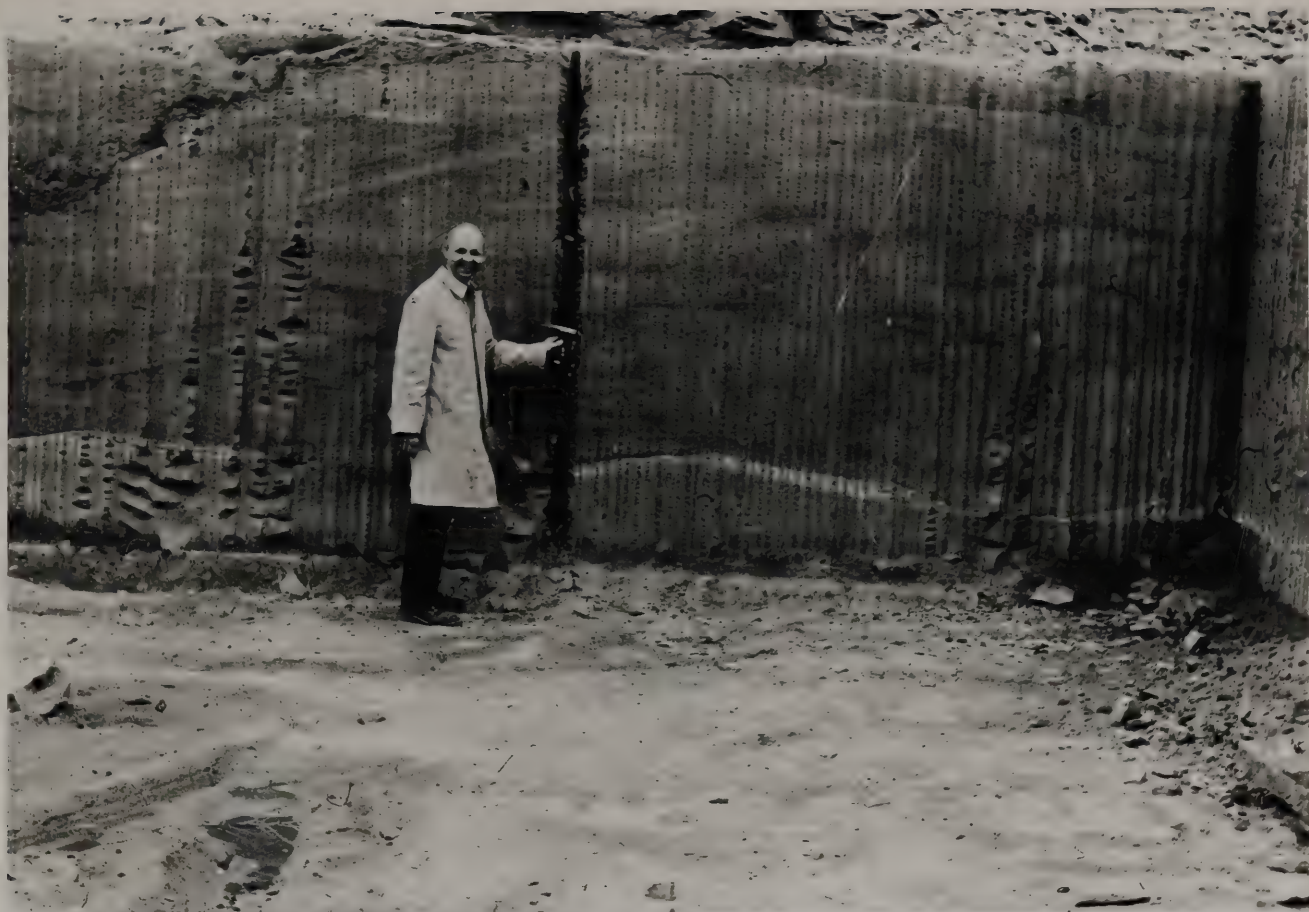
PHOTOGRAPH NO. 4

A view looking west in the quarry at Hulberton. Taken to show the method of quarrying, by means of line drilling, the "lift" that is used for the manufacture of curbing. Note the irregular bedding as shown by streaks and bands of varying tone. This structure has very little if any influence on the direction in which the stone is split, due to thorough cementation and "welding." For the purpose of splitting it is essentially a solid, isotropic block of quartz.

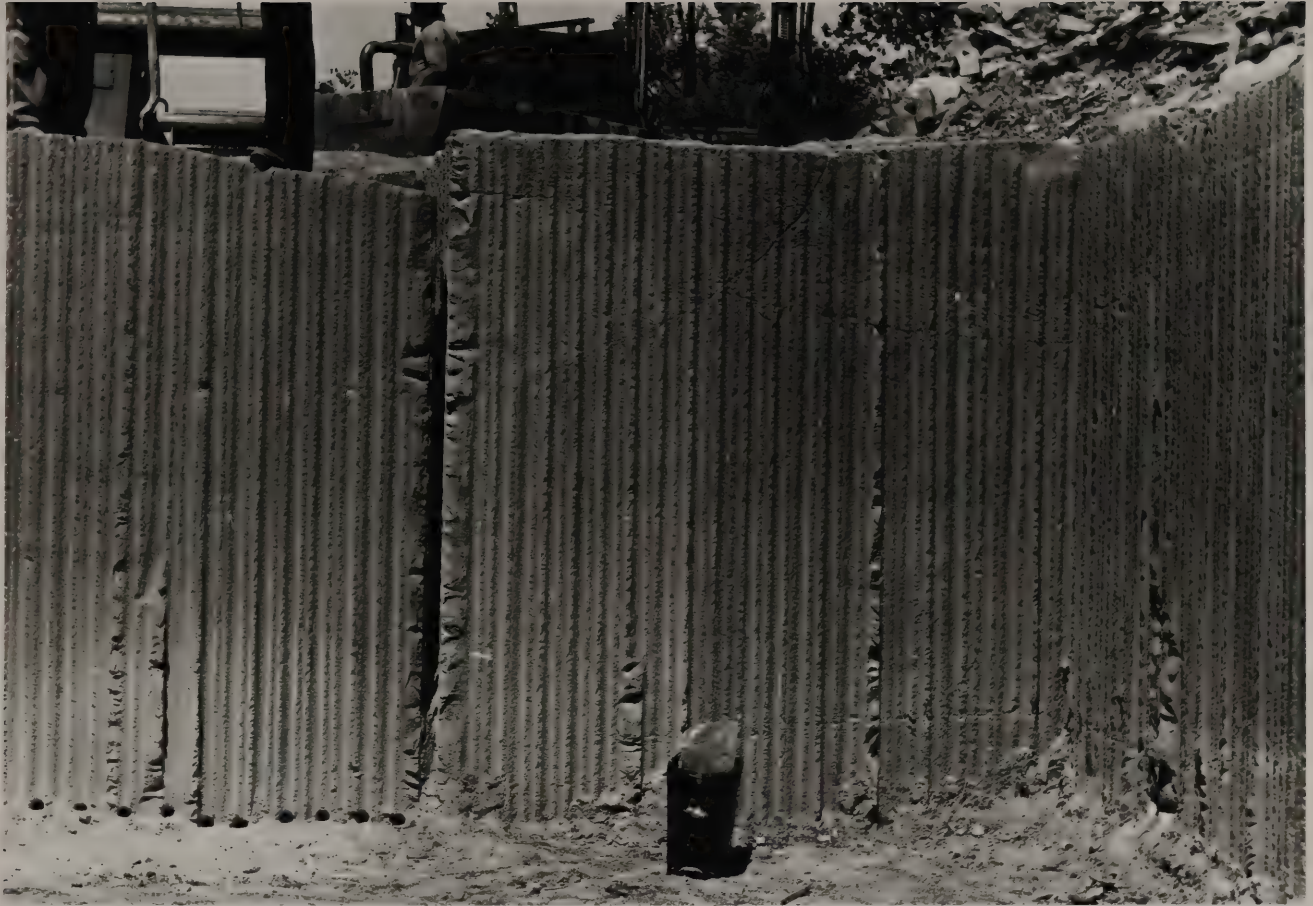
PHOTOGRAPH NO. 5

Nine thin sections were cut from specimens taken at the bottom and at the top of the "lift" being quarried and at 1-foot intervals in between. A microscopic examination has revealed that the only difference in these sections is a slight variation in grain size. They all represent a true orthoquartzite.

Looking east in the Hulberton quarry. Specimens for thin sections were taken at one-foot intervals from bottom to top in this face. Note that stratification shows very indistinctly, if at all.

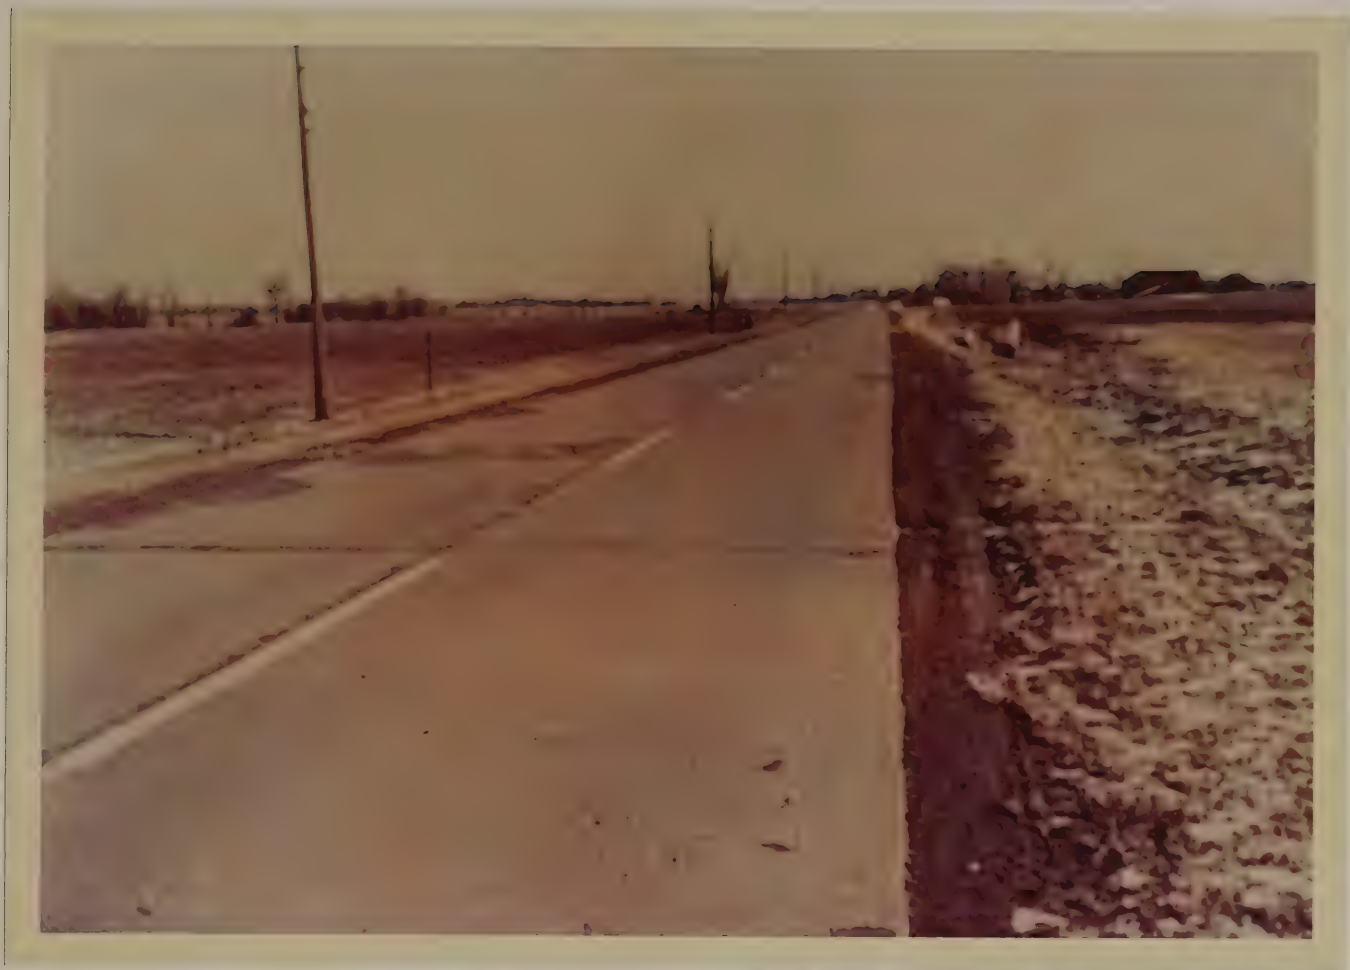
PHOTOGRAPH NO. 1

The concrete in the pavement of Route 18 is certainly of excellent quality. In fact it is perfect except for an occasional small area of surface scaling, which probably occurred soon after construction. There are some areas of fracturing due to foundation failure.

The pavement of Route 18 about a mile east of the intersection of Routes 18 and 98. The dark areas are wet spots. The small areas of surface scaling in the foreground are typical of this feature that occur on a small fraction of one percent of the 15-mile pavement.

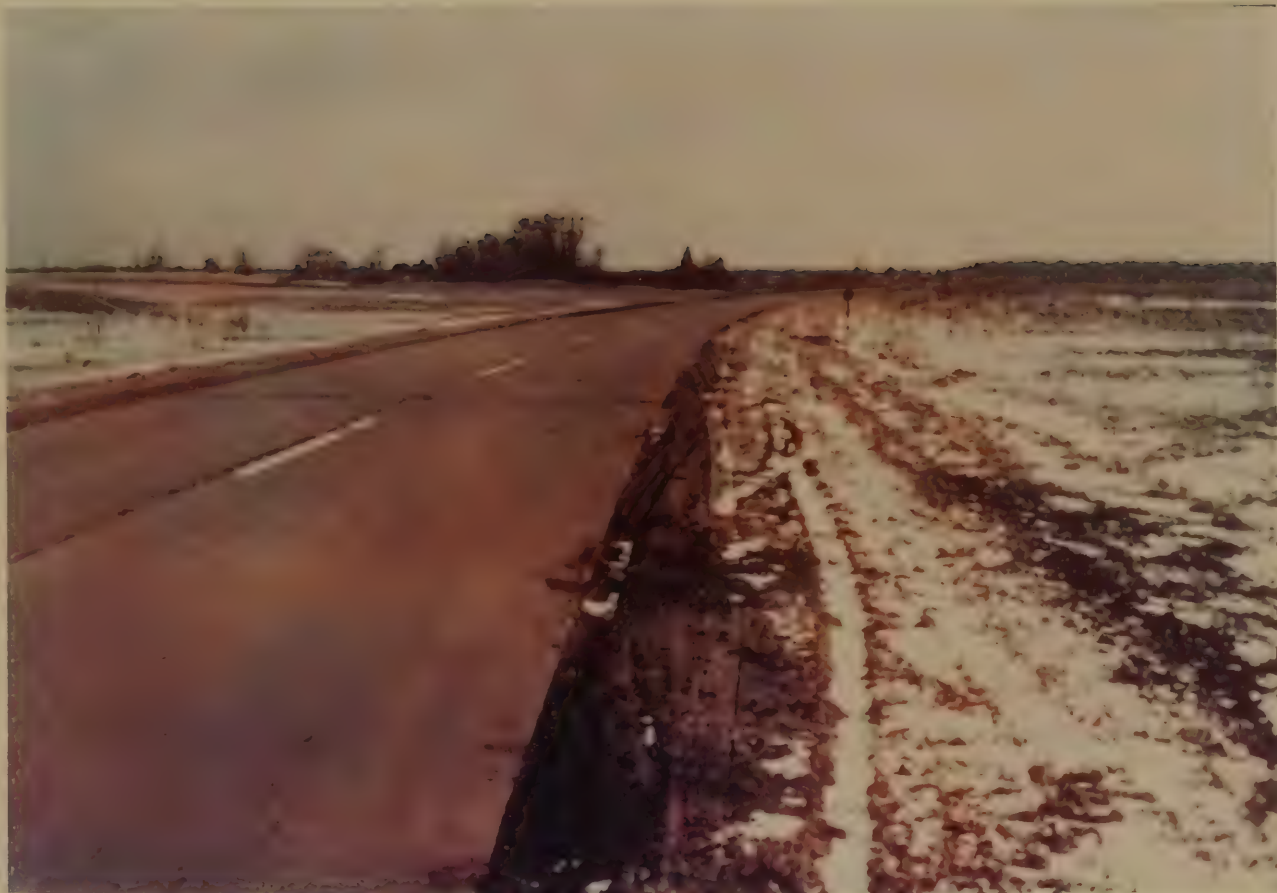
PHOTOGRAPH NO. 2

Another view of the pavement taken five miles east of the intersection of Routes 18 and 98. Note that here, as is the case of most of the 15 miles of this pavement, the highway is raised only slightly or none above the adjacent country. It certainly is not raised enough to assure efficient drainage beneath the pavement.

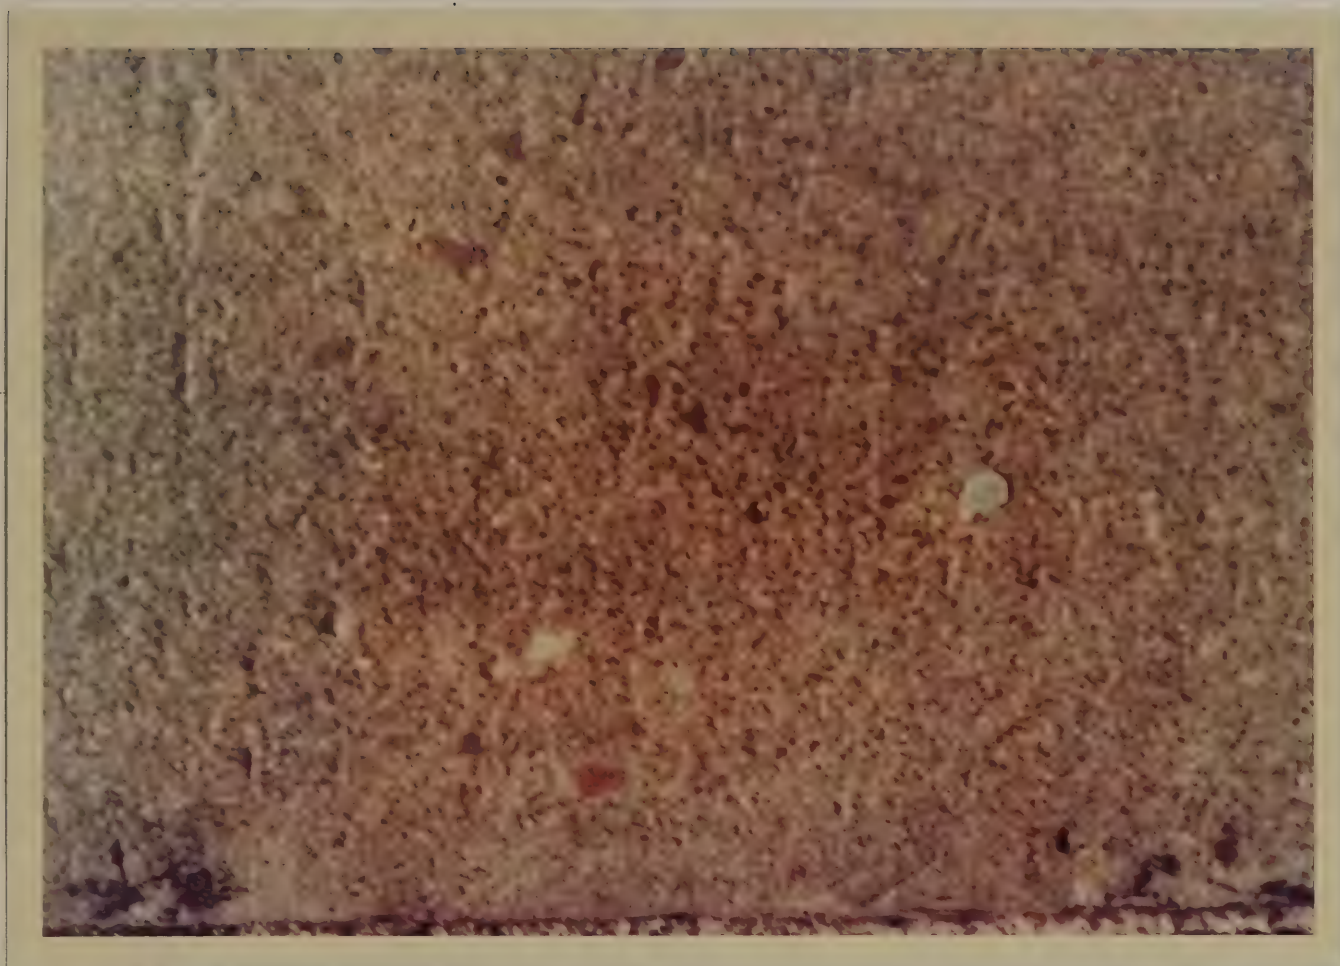
PHOTOGRAPH NO. 3

A close-up showing the texture and average appearance of this 37-year old pavement. The coin is a quarter.

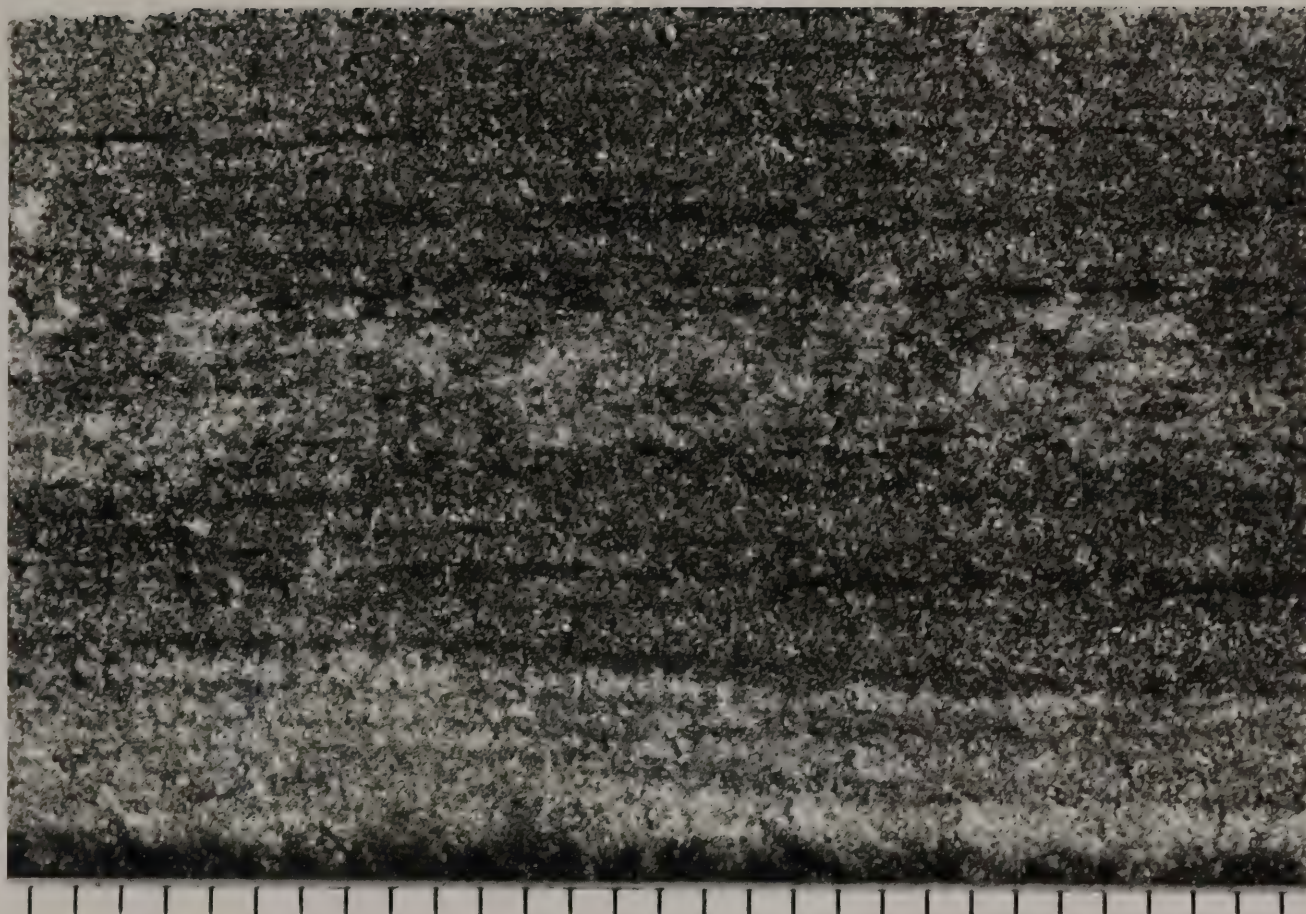
PHOTOGRAPH NO. 4

A macrophotograph of a fractured surface of laminated Medina sandstone. The graduations of the scale are  $\frac{1}{2}$ mm. (1/50 in.). The light laminae are almost white; the dark ones red. None of this type of rock should be permitted in curbing, but due to the very small amount present will not prove deleterious in crushed aggregate. Compare with the following Photograph No. 5.
